COMBINATION OF FLOOD RESILIENCE MEASURES BRING PEACE OF MIND TO RIVERSIDE LIVING

Determined not to sell the flood-prone riverside property he loved, the owner turned to Triton for the specification and supply of effective flood resilience measures. The property, built on the banks of the River Sever in Worcester, had consistently been the victim of flooding since its construction and, just before renovation works which began in 2007, severe flooding caused the water level to rise above the ground floor window sills. Prior to renovation, the original floor slab was cracked and the dpm had failed. There was constant water ingress into the ground floor whenever the river levels rose or during heavy rain.

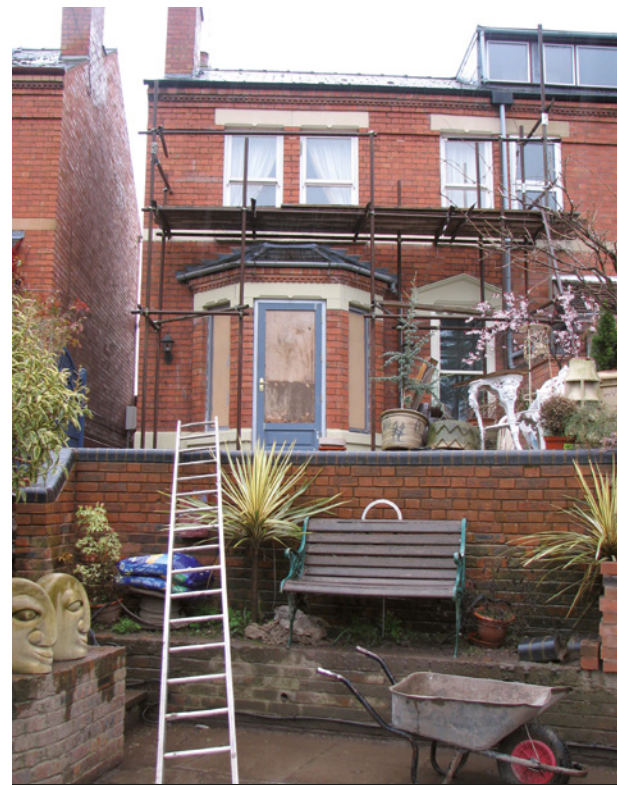
The property is built facing on to the river. The lower half of this terraced garden is lost under water during Winter

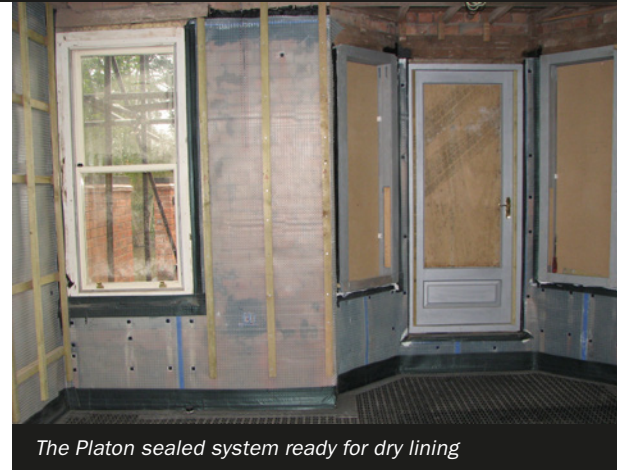
The Platon sealed system ready for dry lining

The Aqua Channel conduit was installed into a channel preformed by shuttering before the new slab was poured. The slab was then lined with high capacity Platon P20 membrane, followed by a reinforced screed and insulation layer, before an underfloor heating system was installed throughout the ground floor. (Triton's TT Super Admix is often specified as a waterproofer within the floor slab mix in this type of application.) Timber floors have since been laid to the living and dining rooms and ceramic tiles in the kitchen. Platon Plasterbase and P5 membranes were fitted to the external and party walls before direct plastering or dry lining as required.

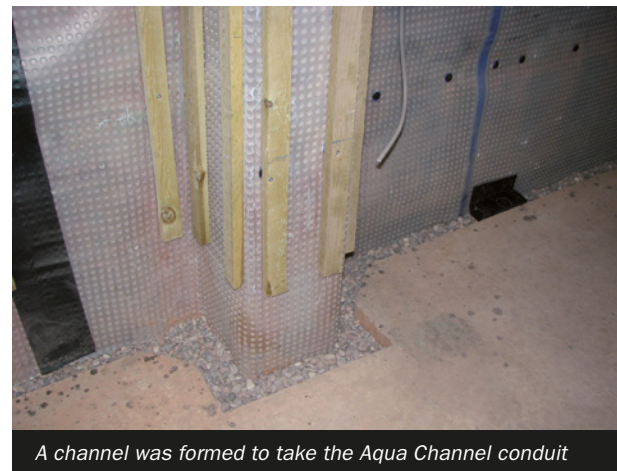
A channel was formed to take the Aqua Channel conduit

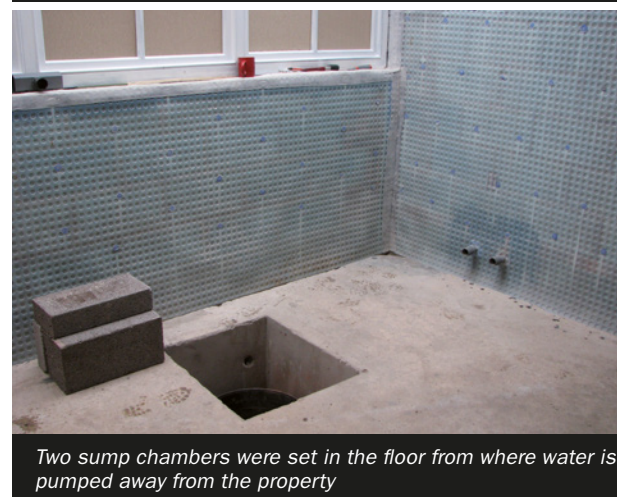
Two sump chambers were set in the floor from where water is pumped away from the property

In view of the high risk of severe flooding of this property, Triton recommended two pumps were installed in each sump chamber to guard against mechanical failure of the first pump and to provide additional pumping capacity when required. Because the success of this system depends entirely on the performance of the pumps, audio and visual high water alarms have also been installed to each sump chamber to ensure the owner can respond to any power failure by the operation of a stand by generator.
